**Flood Control Project Maintenance
Levee Inspections**

Fall 2019 Levee Maintenance Deficiency Summary Report

Sacramento River Basin

**Flood Control Project Maintenance
Levee Inspections****LMA District Cover Sheet****Fall 2019 Levee Inspection Results****Reclamation District No. 0003 Grand Island**

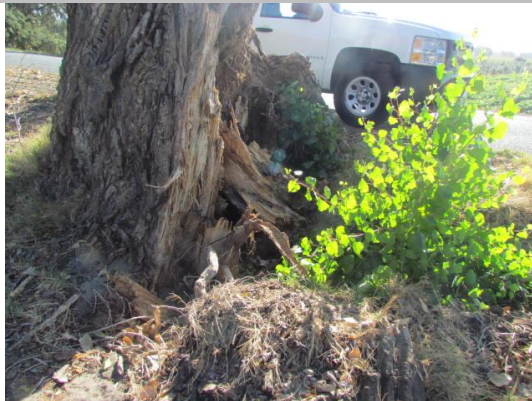
Photo 2 of 3 : FA_2019_RD0003_24_2_20190826_00002.jpg

Looking at a hole next to oak tree on waterward shoulder. (2015)

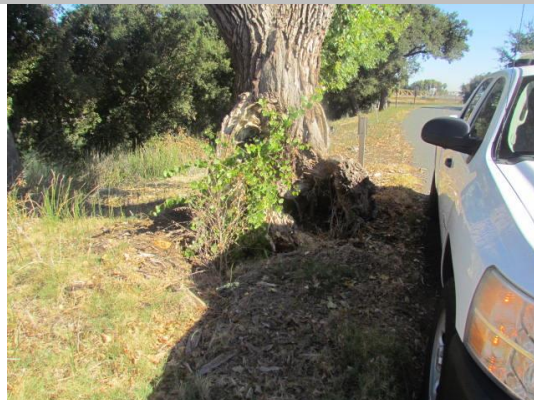
Photo 3 of 3 : FA_2019_RD0003_24_2_20190826_00003.jpg

LM Start	0.13	Rating **	M	Issue No.	2 (cont)	
LM End	0.13	Issue Type +	Ma	Location *	WS	
Category	Earthen Levee			GPS Latitude/Longitude		
				Start		End
Item	Erosion / Bank Caving			38.303303 °		38.303303 °
				-121.576538 °		-121.576538 °
DWR ID	DWR_RD0003_01_f_2013_2					
Comment Code						
E2 : Schedule repair of erosion site prior to the next inspection.						
Inspector Comment						
A hole (8ft x 2.5ft x 5ft) is next to a large tree on waterward shoulder.

Looking east at hole at base of tree on waterward shoulder. (2014)

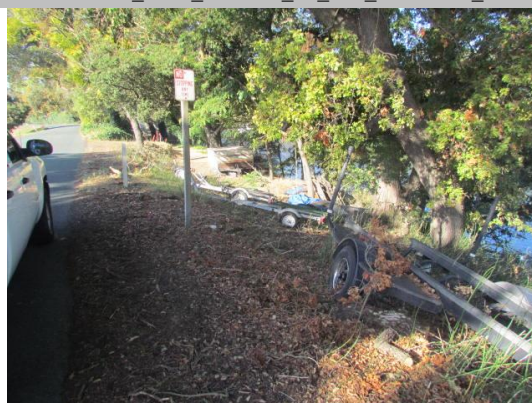
Photo 3 of 4 : FA_2019_RD0003_24_188_20190826_00092.jpg

Looking southwest at equipment and garbage stored on waterward slope and toe. (Spring 2014)

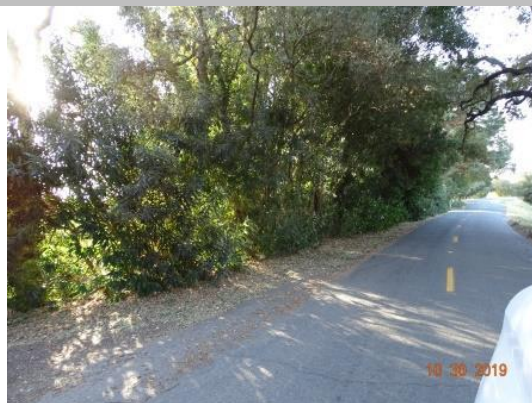
Photo 1 of 1 : FA_2019_RD0003_24_21_20191031_00166.jpg

View looking downstream at landscaping on the landside slope (Fall 2019).

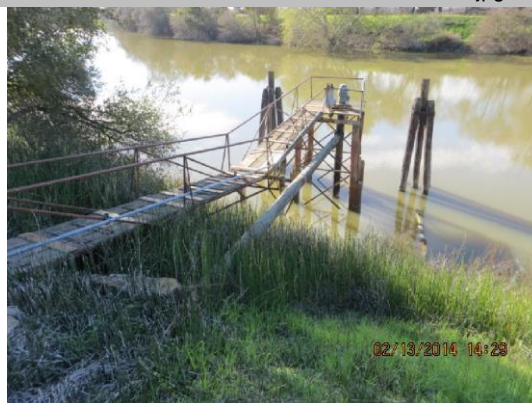
Photo 1 of 3 : UCIP_FA_2019_31287_57298.jpg

LM Start	1.32	Rating **	M	Issue No.	190
LM End	1.32	Issue Type +	En	Location *	
Category	Supplemental			GPS Latitude/Longitude	
				Start	End
Item	DRAFT DWR UCIP Field Study			38.287515 °	38.287515 °
				-121.582925 °	-121.582925 °
DWR ID	24838				
Comment Code					
Inspector Comment					
DS_ID:24838					
FS_ID:31287					
EP_NO: N/A					
Repair Type: Non-Urgent					
Crossing Status: Found					
UCIP Comments: Appears abandoned and if so should be done so properly.					
FIELD_STRUCT_DESC: *ABANDONED* 2.5-inch galvanized iron irrigation pipe through the levee, 4 feet below the crown. 1.25-inch galvanized iron electrical conduit at the same location.					
FS Date: 2/13/2014

Walkway to pier on WS shoulder.

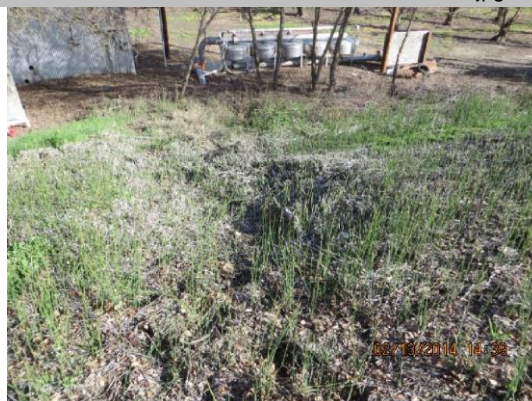
Photo 2 of 3 : UCIP_FA_2019_31287_57297.jpg

Pipe visible just off LS shoulder in vegetation.

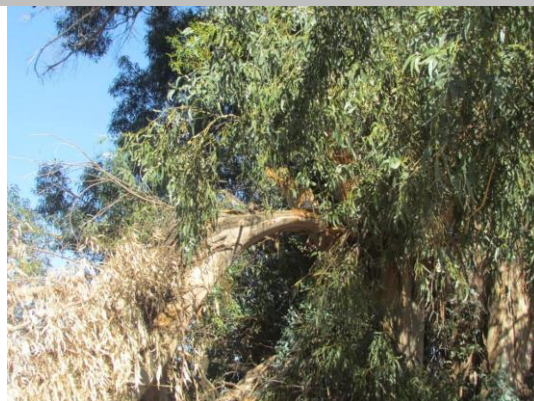
Photo 1 of 2 : FA_2019_RD0003_24_62_20190826_00049.jpg

LM Start	1.69	Rating **	M	Issue No.	62
LM End	1.69	Issue Type +	Ma	Location *	WS
Category	Earthen Levee			GPS Latitude/Longitude	
				Start	End
Item	Encroachments			38.283747 °	38.283747 °
				-121.587622 °	-121.587622 °
DWR ID	DWR_RD0003_01_f_2016_62				
Comment Code					
TR : Tree or limb					
Inspector Comment					
There is a broken tree branch on the waterward slope.

Looking southwest at broken branches on waterward slope.

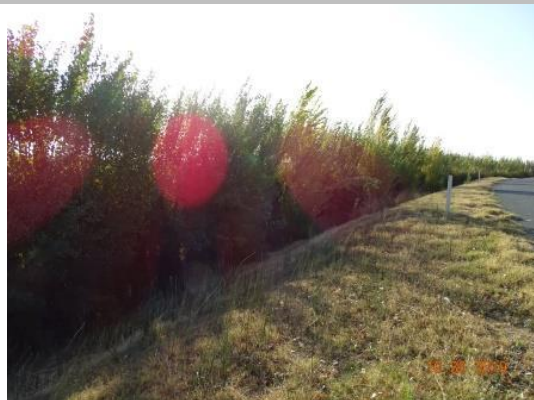
Photo 1 of 1 : FA_2019_RD0003_24_57_20191031_00173.jpg

View looking downstream at closely spaced trees at the landside toe (Fall 2019).

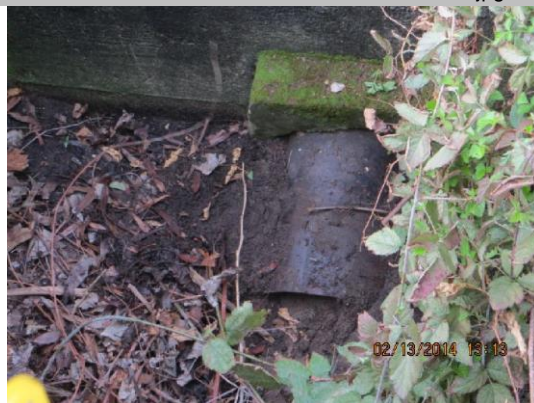
Photo 1 of 2 : UCIP_FA_2019_29567_54634.jpg

Pipe visible inside concrete distribution box on LS toe.

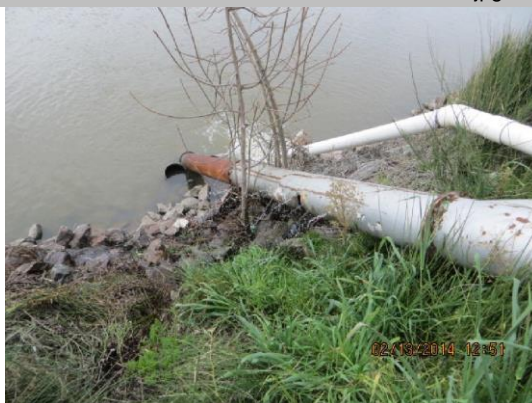
Photo 1 of 3 : UCIP_FA_2019_29563_54622.jpg

Intake pipe at slantpump on WS slope.

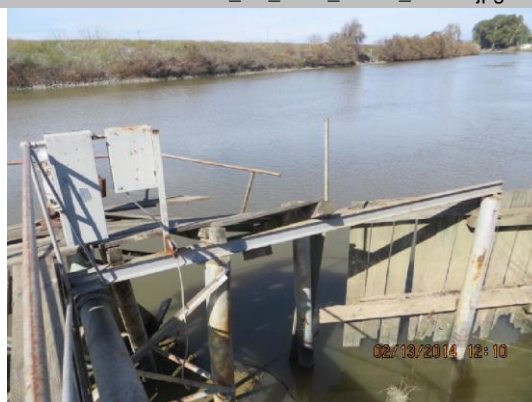
Photo 2 of 3 : UCIP_FA_2019_29547_54610.jpg

Damaged pump platform at WS toe.

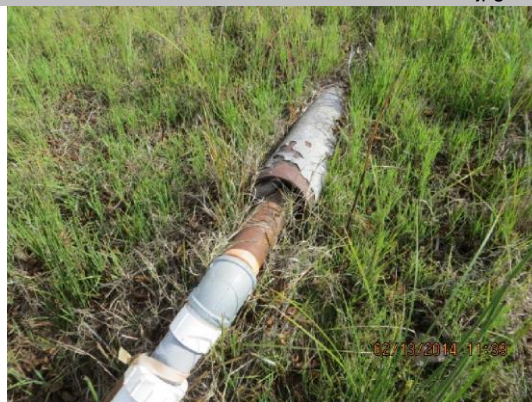
Photo 2 of 3 : UCIP_FA_2019_29530_54591.jpg

Conduits running through pipe on WS slope.

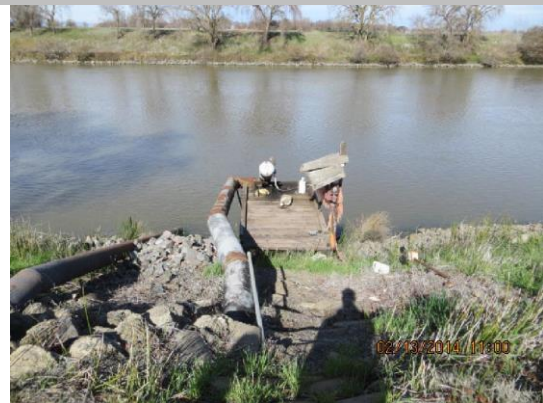
Photo 2 of 2 : UCIP_FA_2019_31583_57840.jpg

Pipe visible on WS slope with pump on pier and electrical conduit.

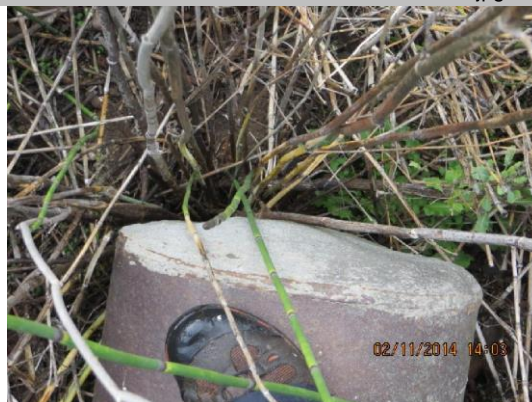
Photo 2 of 3 : UCIP_FA_2019_29403_54461.jpg

Concrete plug in abandoned pipe on WS slope.

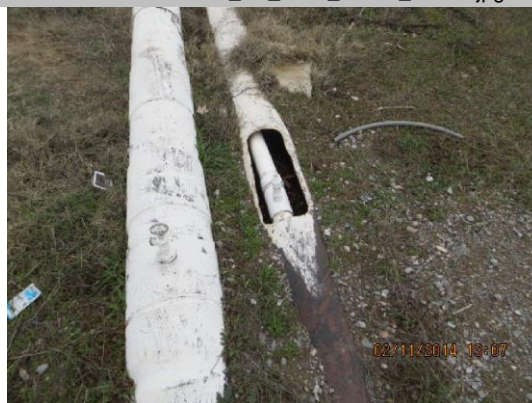
Photo 3 of 3 : UCIP_FA_2019_50428_54122.jpg

3.5-inch PVC pipe sleeved through pipe on LS shoulder.

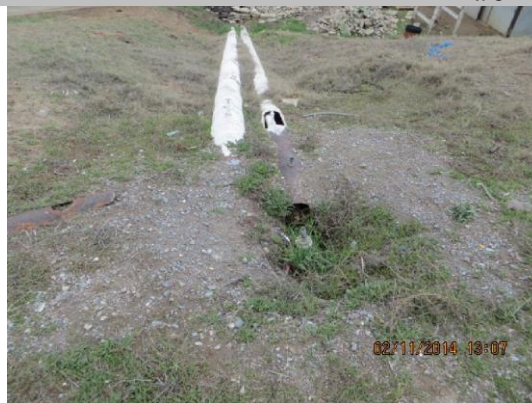
Photo 2 of 3 : UCIP_FA_2019_50427_54132.jpg

PVC pipe visible on LS slope.

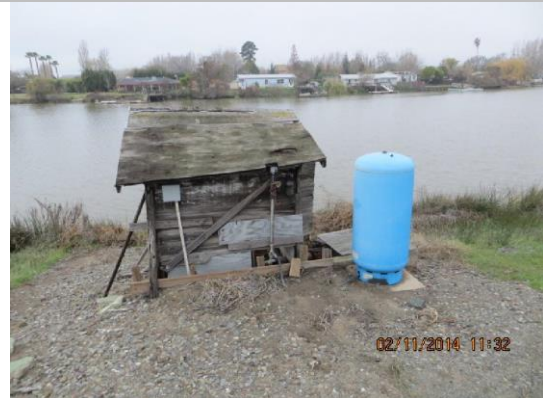
Photo 3 of 3 : UCIP_FA_2019_29235_54051.jpg

Pump and tank on WS shoulder.

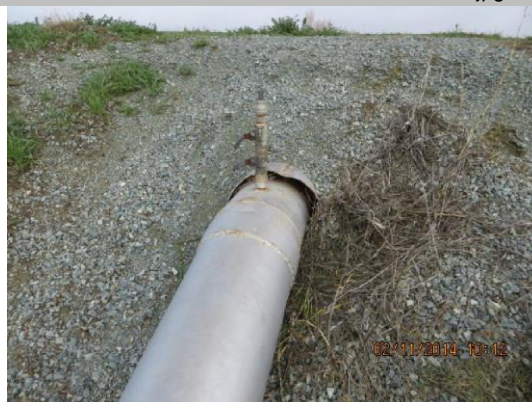
Photo 3 of 3 : UCIP_FA_2019_29187_53950.jpg

Annular space not grouted between pipes.

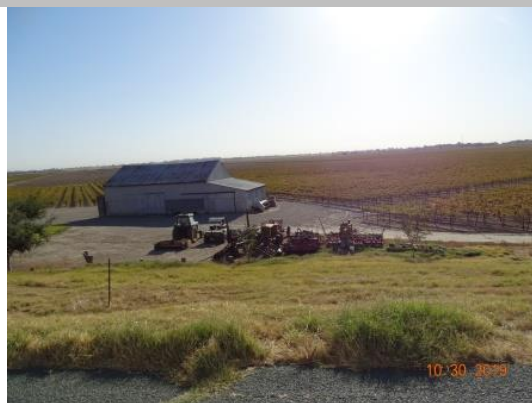
Photo 1 of 1 : FA_2019_RD0003_24_100_20191031_00187.jpg

View of farming equipment at the landside toe (Fall 2019).

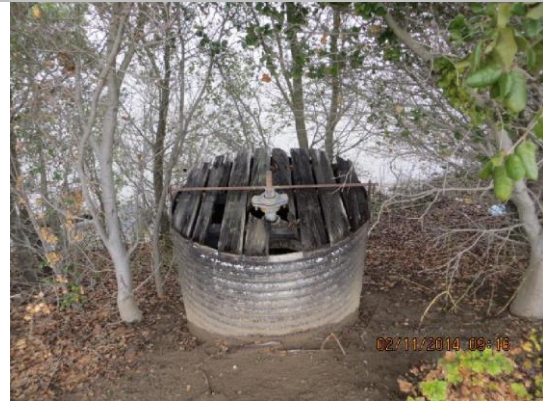
Photo 2 of 3 : UCIP_FA_2019_29165_53865.jpg

Slide gate in 48-inch CMP riser on WS shoulder.

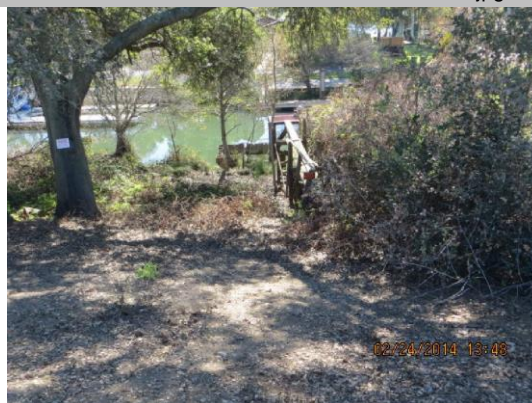
Photo 1 of 3 : UCIP_FA_2019_31083_56982.jpg

Pump on pier on WS slope.

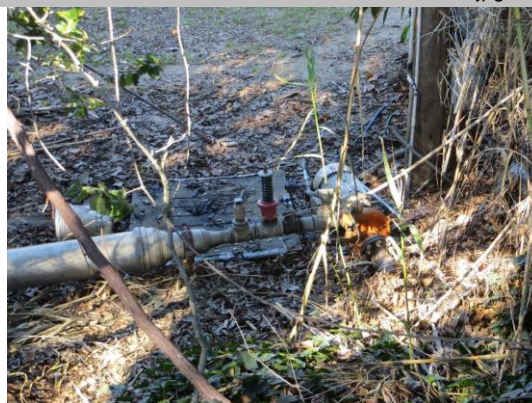
Photo 1 of 3 : UCIP_FA_2019_30963_56862.jpg

Pump, shutoff, power pole, and vent on LS toe.

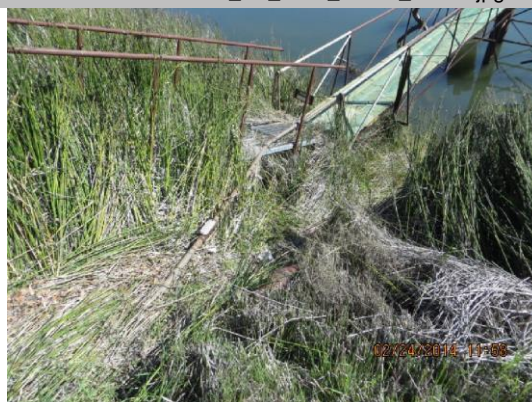
Photo 3 of 3 : UCIP_FA_2019_30963_56860.jpg

Pipe visible to right of walkway on LS slope.

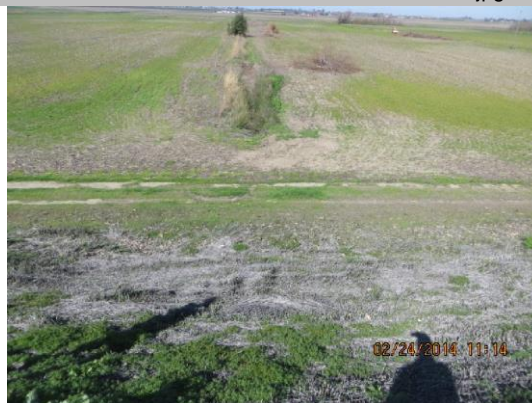
Photo 2 of 2 : UCIP_FA_2019_30903_56800.jpg

Swale off LS toe likely along same alignment as pipe.

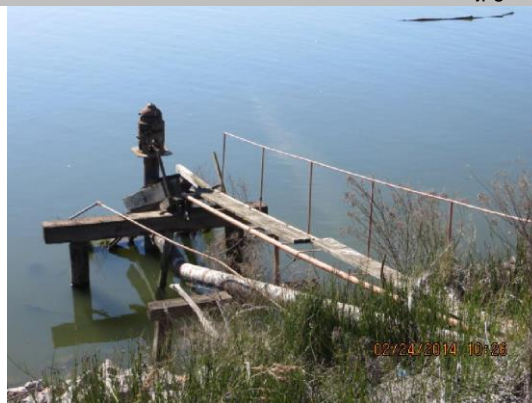
Photo 1 of 3 : UCIP_FA_2019_41643_56793.jpg

Pump on structurally failing pier/walkway on WS toe.

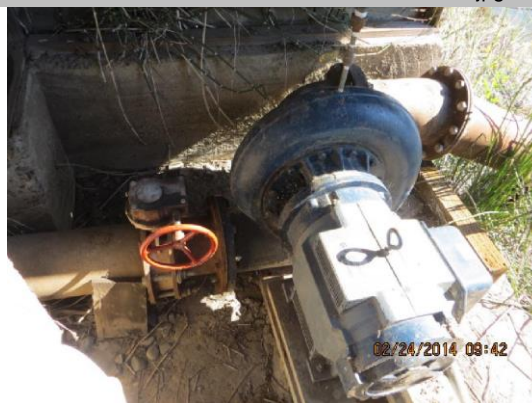
Photo 1 of 3 : UCIP_FA_2019_30864_56747.jpg

Pump and gate valve inside pumphouse on WS slope.

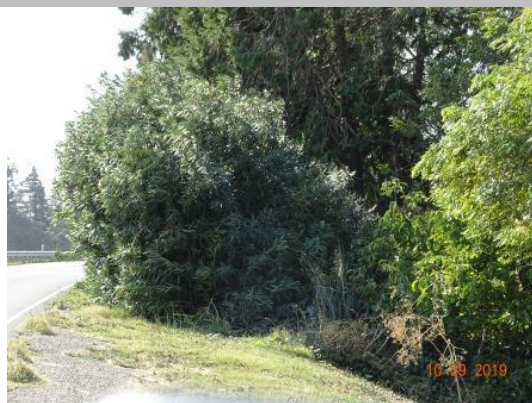
Photo 1 of 1 : FA_2019_RD0003_25_88_20191030_00345.jpg

View looking downstream at landscaping on the landside slope (Fall 2019).

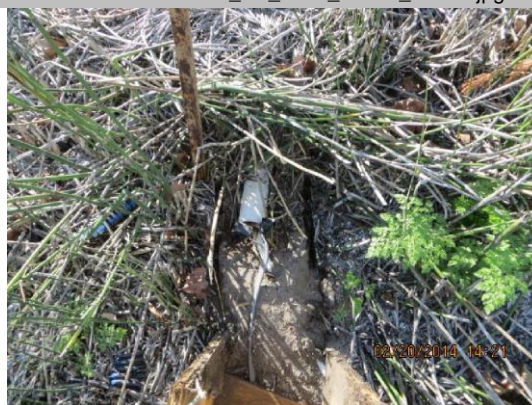
Photo 1 of 2 : UCIP_FA_2019_31291_57310.jpg

Pipe visible on WS slope.

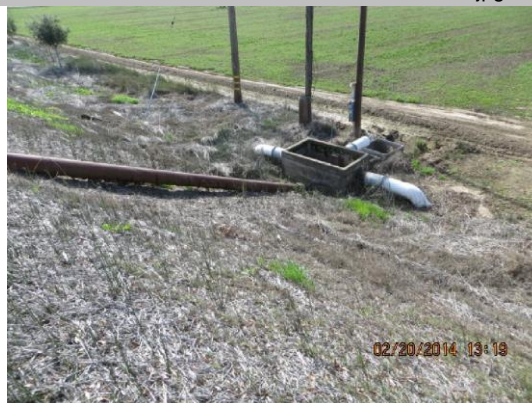
Photo 1 of 3 : UCIP_FA_2019_30648_56414.jpg

Pipe visible on LS slope with concrete distribution box on LS toe.

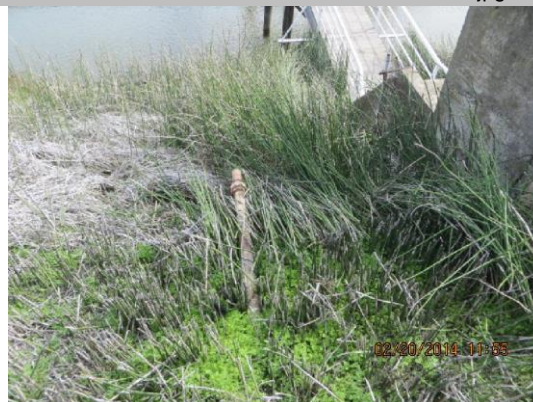
Photo 1 of 1 : UCIP_FA_2019_30588_56377.jpg

Pipe visible next to concrete culvert on WS slope.

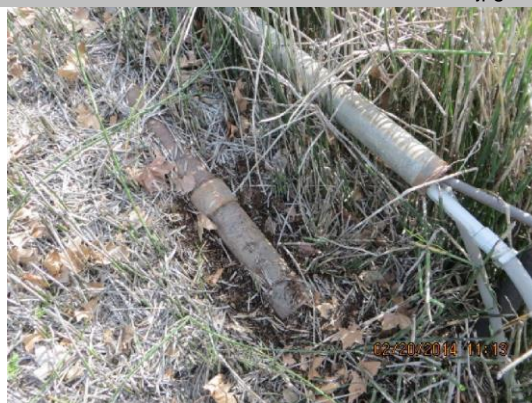
Photo 1 of 1 : UCIP_FA_2019_30568_56321.jpg

Steel pipe visible on LS Slope.

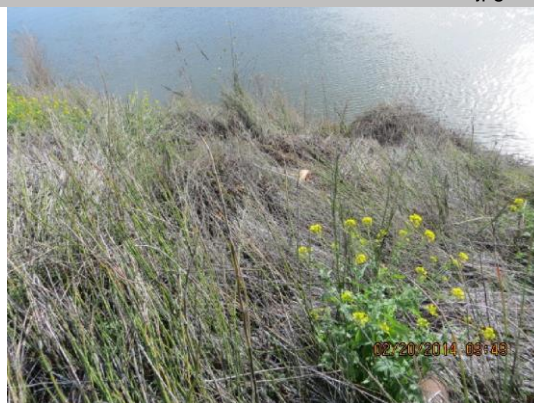
Photo 1 of 3 : UCIP_FA_2019_30507_56120.jpg

Pipe and pump covered by vegetation on WS slope.

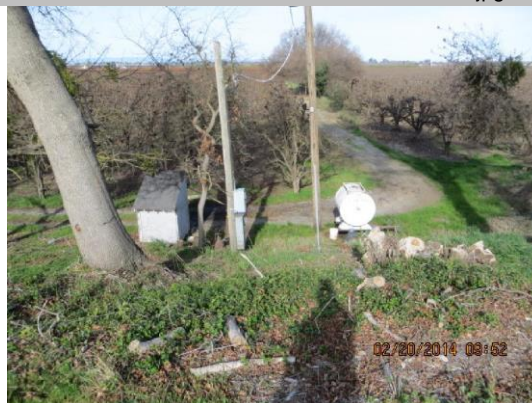
Photo 3 of 3 : UCIP_FA_2019_30507_56118.jpg

Pipe to left of power pole and meter at LS toe.

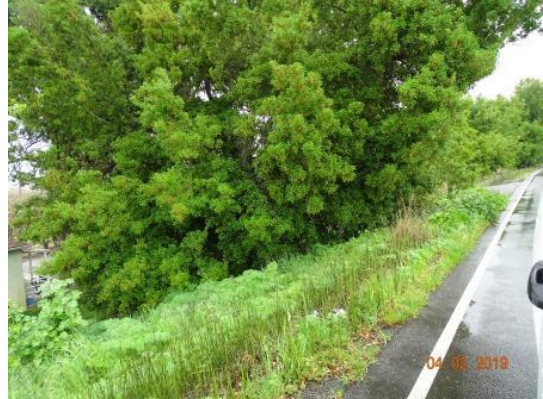
Photo 1 of 1 : FA_2019_RD0003_25_63_20190826_00042.jpg

View looking upstream at thick trees on the landside slope (Spring 2019).

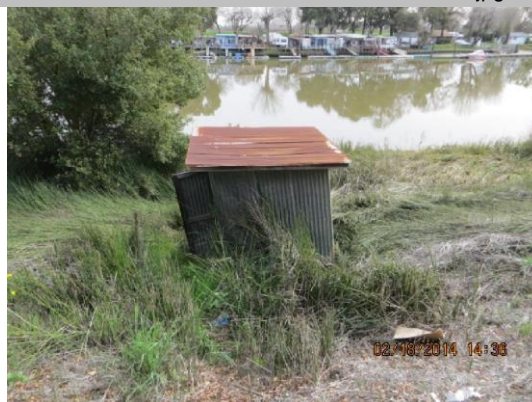
Photo 2 of 3 : UCIP_FA_2019_31349_57434.jpg

Pumphouse on WS slope.

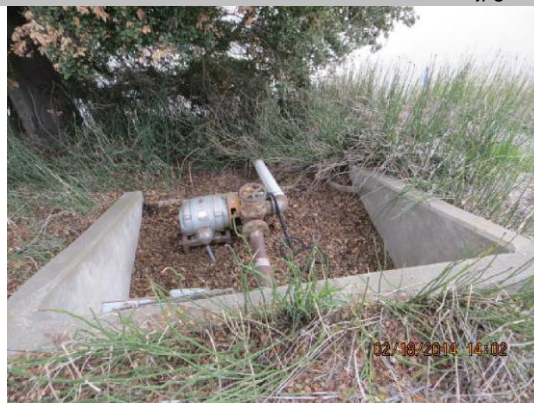
Photo 1 of 3 : UCIP_FA_2019_30408_55931.jpg

Pump and shutoff valve on concrete pad on WS slope.

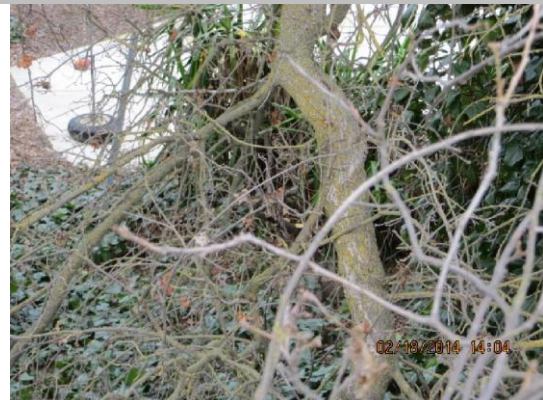
Photo 3 of 3 : UCIP_FA_2019_30408_55929.jpg

Concrete standpipe covered in vegetation on LS toe.

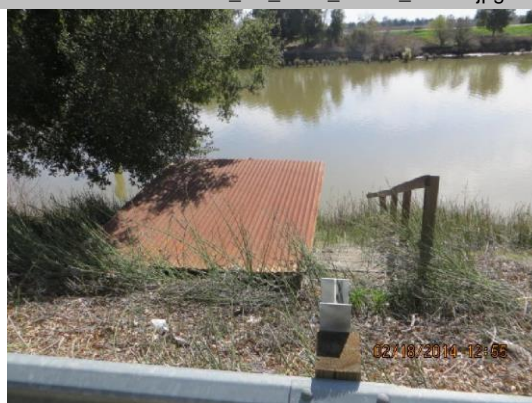
Photo 2 of 3 : UCIP_FA_2019_30364_55845.jpg

Pipe visible in abandoned pump house on WS slope.

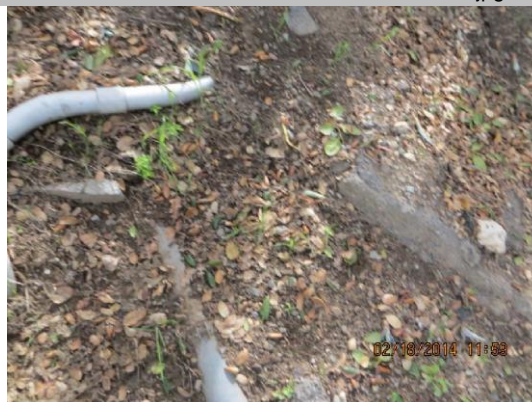
Photo 1 of 3 : UCIP_FA_2019_30353_55827.jpg

Electrical conduit visible on LS slope.

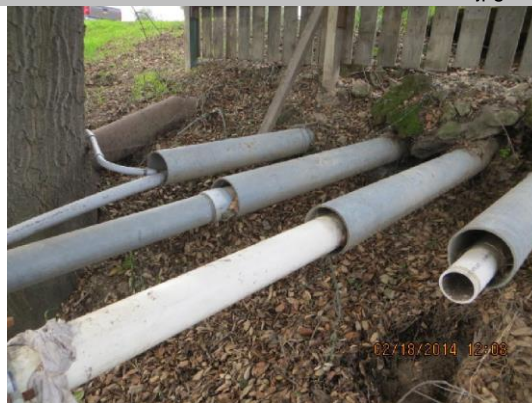
Photo 3 of 3 : UCIP_FA_2019_30353_55825.jpg

Electrical conduit visible at WS shoulder at 6-inch conduit it is sleeved through.

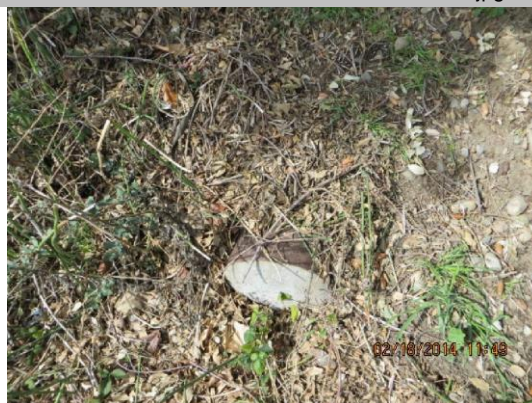
Photo 1 of 3 : UCIP_FA_2019_30345_55789.jpg

Pipe with concrete fill on WS slope.

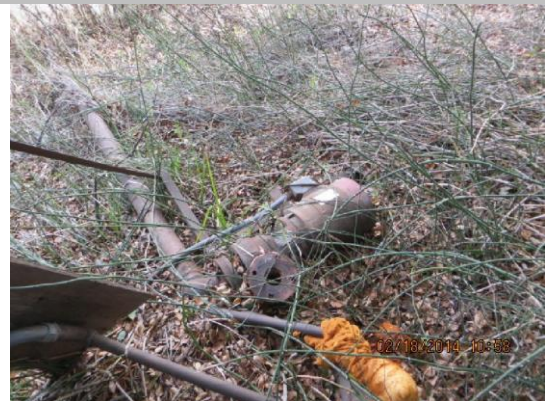
Pipe and pump visible on WS slope.

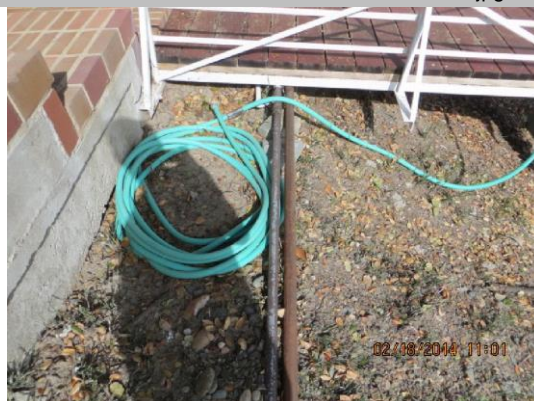
Photo 3 of 3 : UCIP_FA_2019_30306_55728.jpg

2-steel pipes run parallel to crown on WS slope from pump to boat walkway, 210-feet upstream from pump.

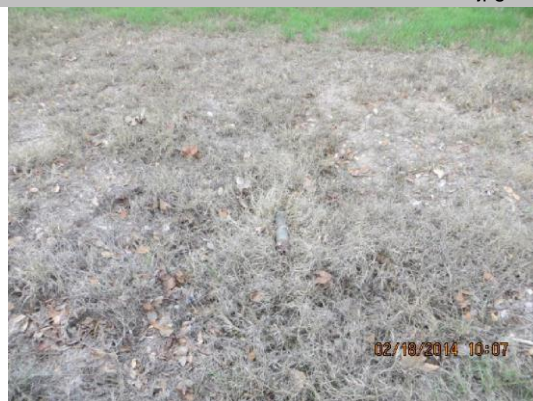
Photo 3 of 3 : UCIP_FA_2019_30286_55687.jpg

Pipe visible on LS slope.

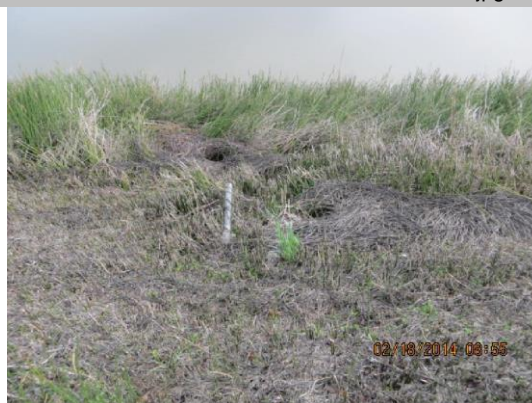
Photo 1 of 3 : UCIP_FA_2019_41585_55628.jpg

Pipe visible on WS slope.

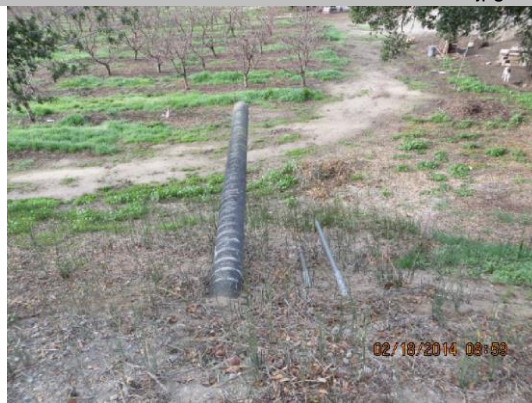
Photo 3 of 3 : UCIP_FA_2019_41585_55626.jpg

Pipe visible on LS slope.

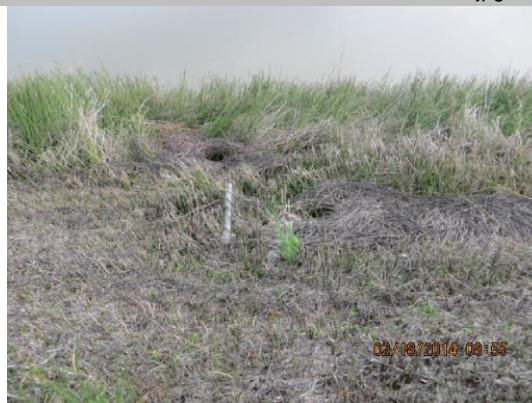
Photo 2 of 3 : UCIP_FA_2019_30204_55604.jpg

Pipe visible on WS slope.

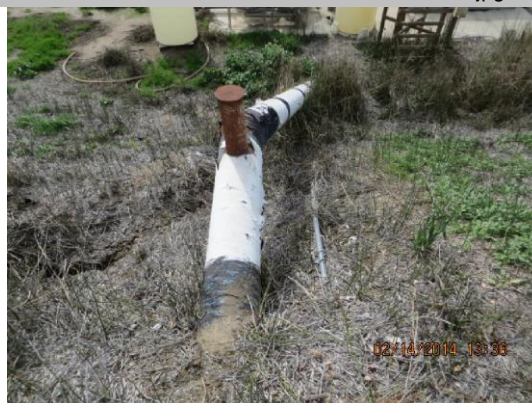
Photo 1 of 3 : UCIP_FA_2019_30203_55602.jpg

Pipe, vent, and electrical conduit visible on LS slope.

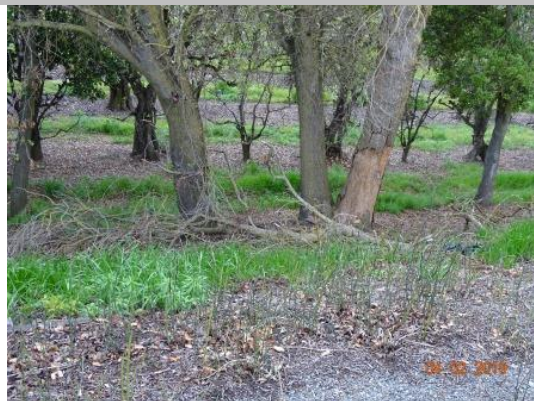
Photo 1 of 1 : FA_2019_RD0003_25_132_20190826_00103.jpg

View looking downslope at tree limbs on the landside slope (Spring 2019).

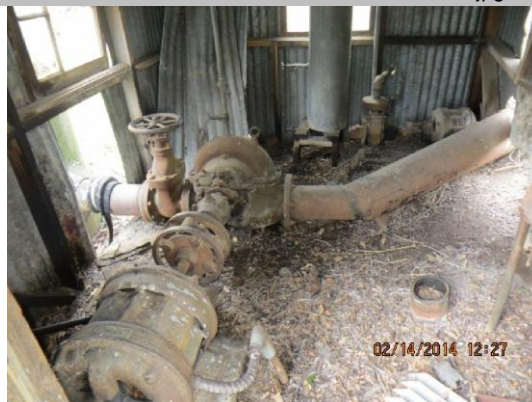
Photo 3 of 3 : UCIP_FA_2019_30165_55566.jpg

Pump and gate valve visible in pumphouse. Connection to concrete standpipe failing.

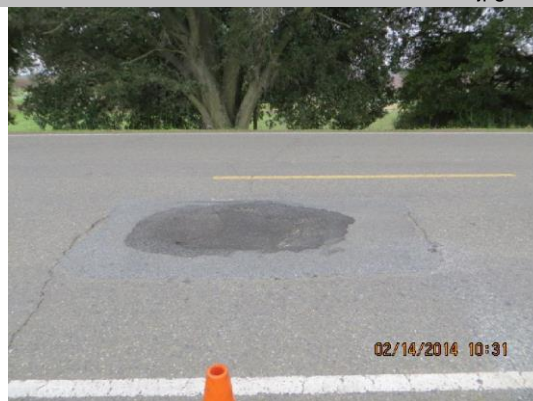
Photo 2 of 3 : UCIP_FA_2019_53536_55361.jpg

Apparent sinkhole over pipe at crown.
